# SCAFFOLD & ACCESS MAGAZINE

# Engineering in the shadow of history

The award-winning suspended access innovation that helped restore the US Holocaust Memorial Museum's bridges – without leaving a trace

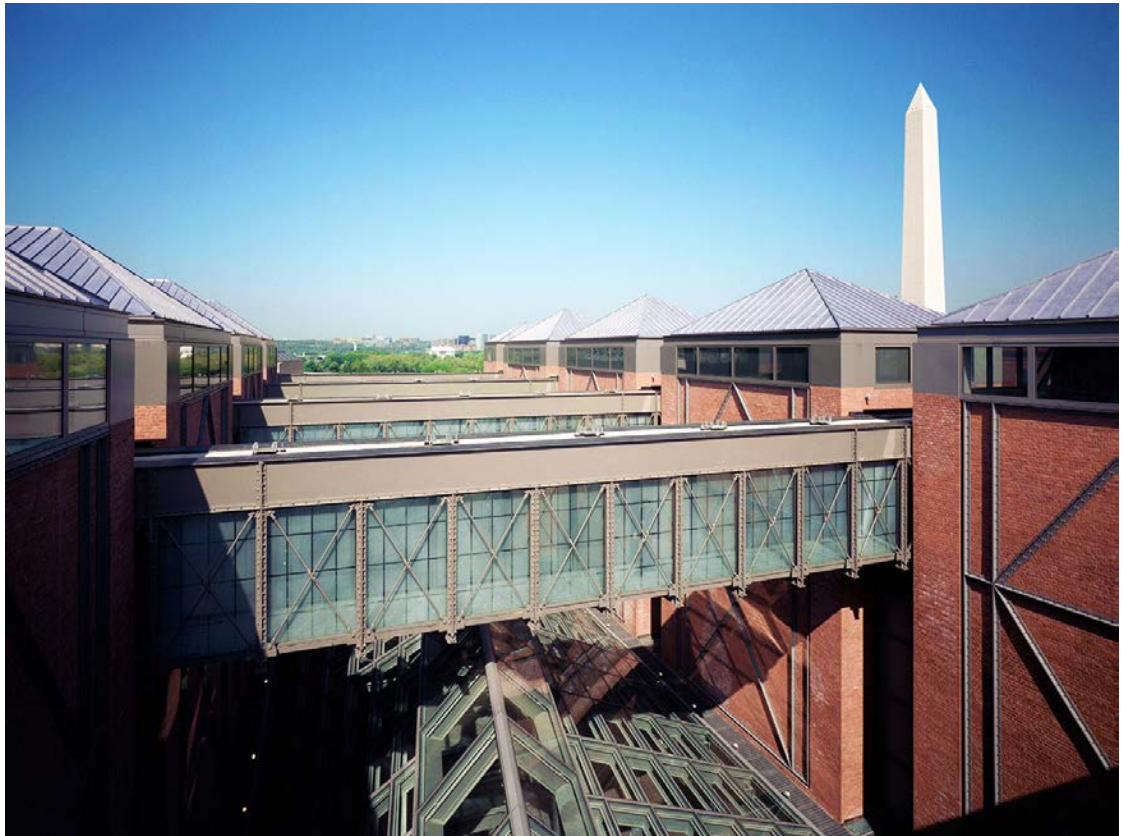
Traditional ground-supported scaffolding wasn't an option due to the glass atrium below the bridges.

The constraints weren't just challenging. They were absolute. Traditional ground-supported scaffolding wasn't an option. The glass atrium below the bridges eliminated any possibility of loading from beneath. Every pound of support would need to come from above.

"Suspended access was the only viable solution for this job due to the design of the surrounding structure," Andrews explains. "A glass atrium below the bridges not only limited the work to access solutions supported from above, but it also posed an increased need for flawless execution due to the delicacy of the surface below."
