REPAIRING AN ICONIC CONNECTION

Bee Access recently played a pivotal role in restoring NYC's Brooklyn Bridge – and took home a Scaffold & Access Industry Association Project of the Year Award for it. **Brian Andrews**, VP of engineering at Bee Access, reports.

The Brooklyn Bridge restoration project located in New York City encompassed the cleaning, inspection and repair of the granite slabs located on each tower of the bridge. For workers to access the façade, it required standard suspended access equipment complemented with specially designed rigging accessories and special support beams secured to the existing tower structure.

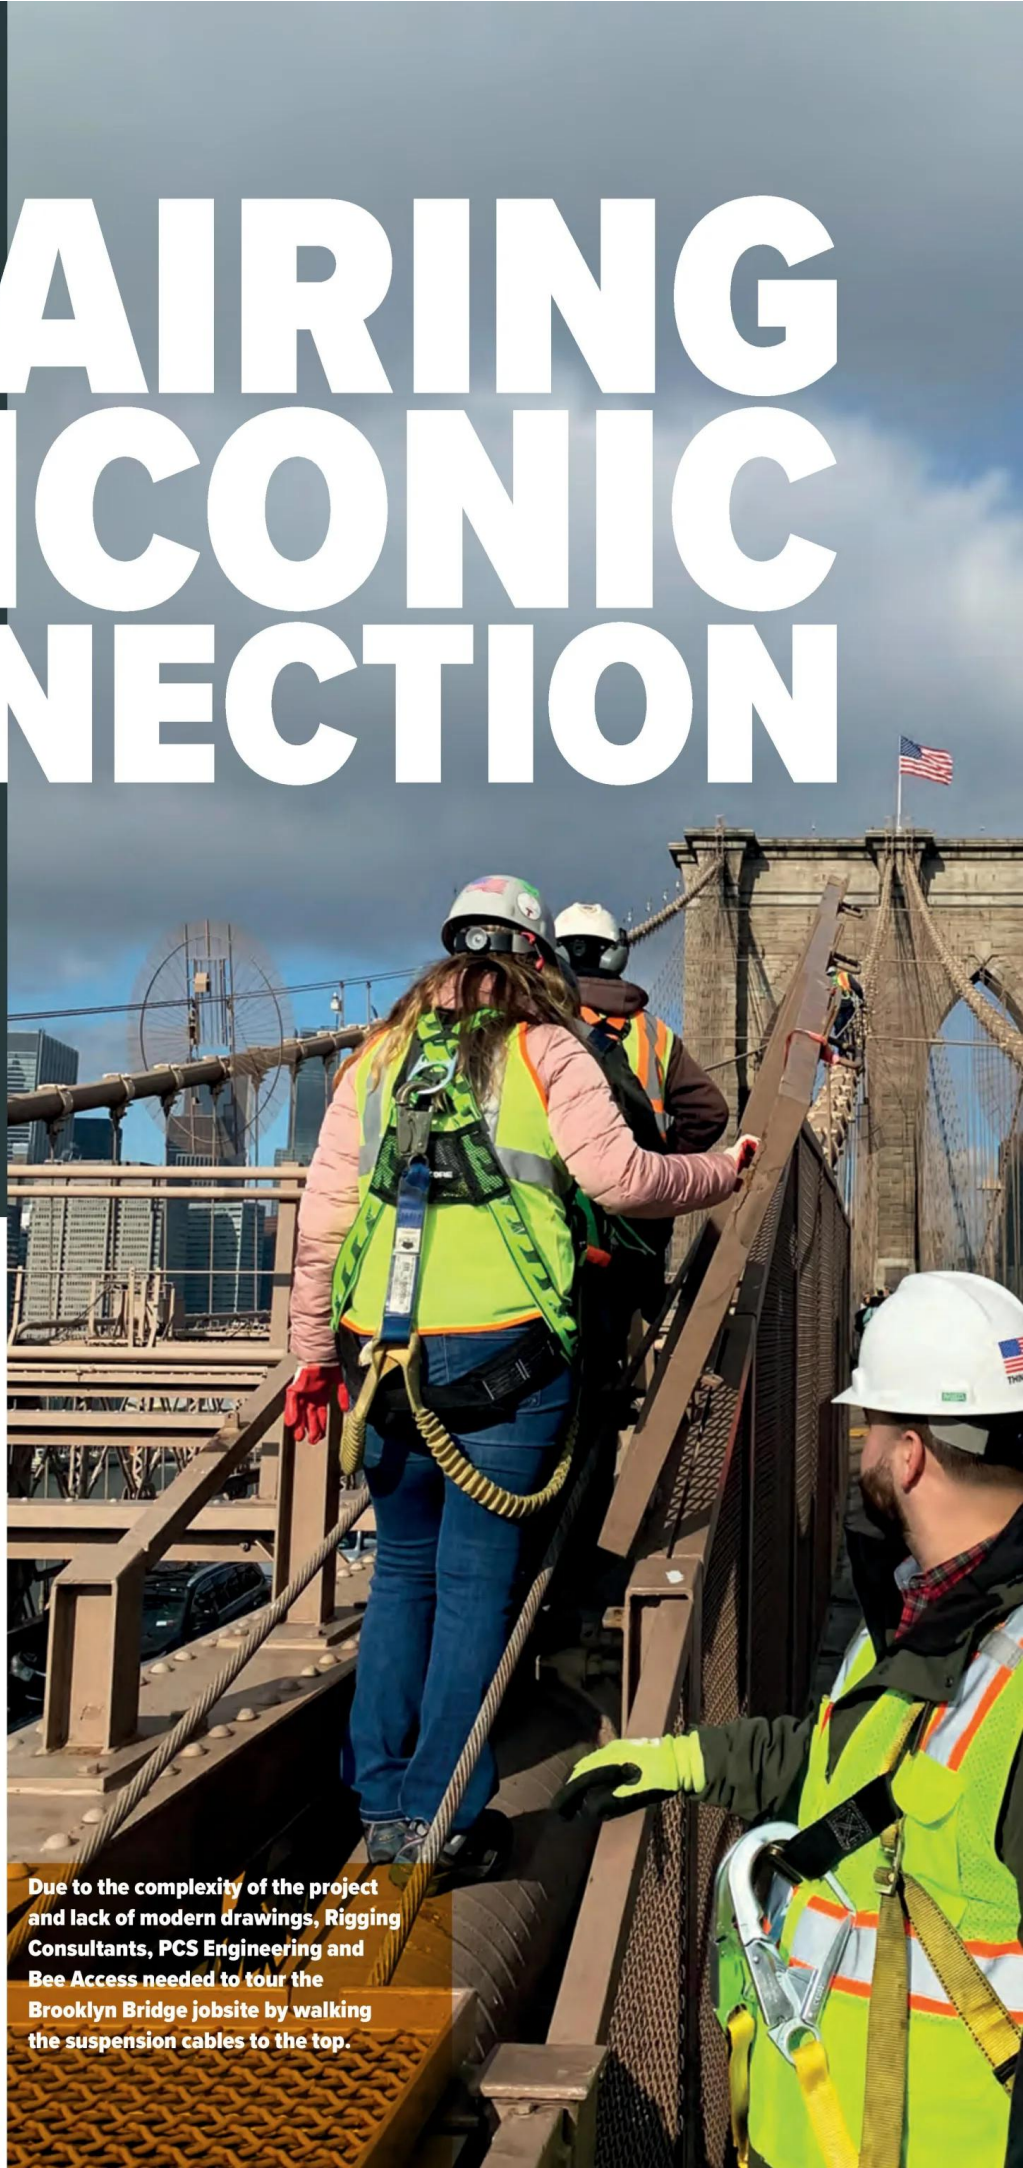
Due to the complexity of the project and lack of modern drawings, Rigging Consultants, PCS Engineering and Bee Access needed to tour the Brooklyn Bridge jobsite by walking the suspension cables to the top.

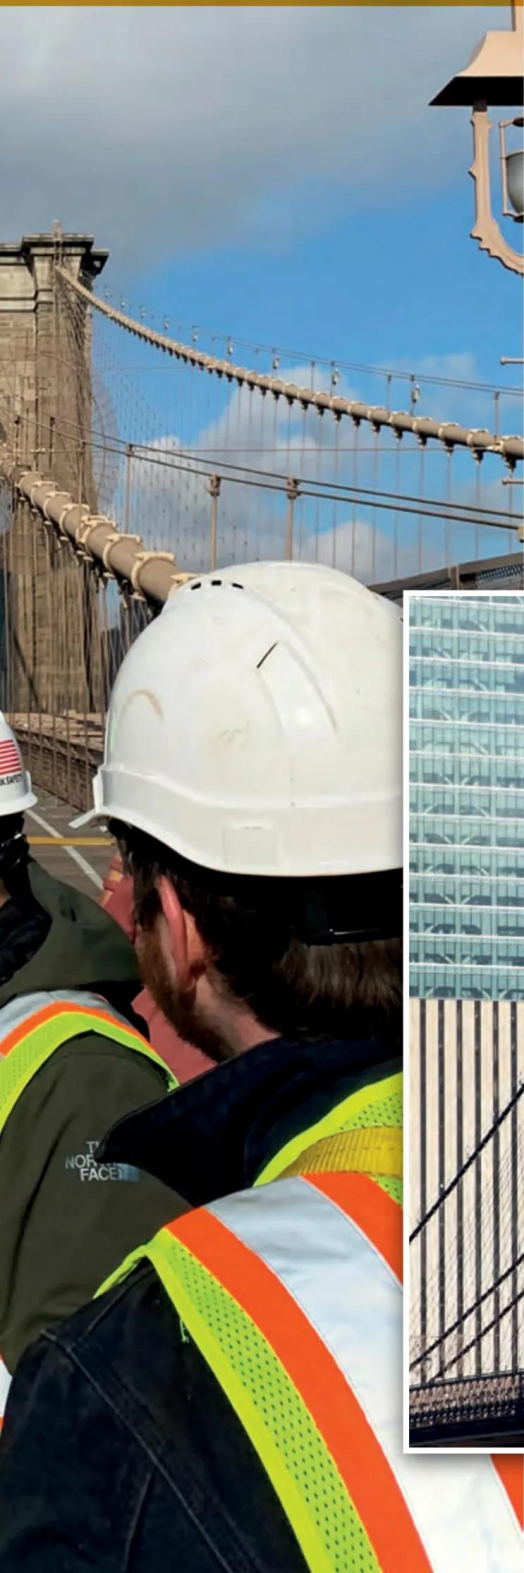
All rigging assembled on one tower with a material hoist seen on the top left and three suspended platforms in use.

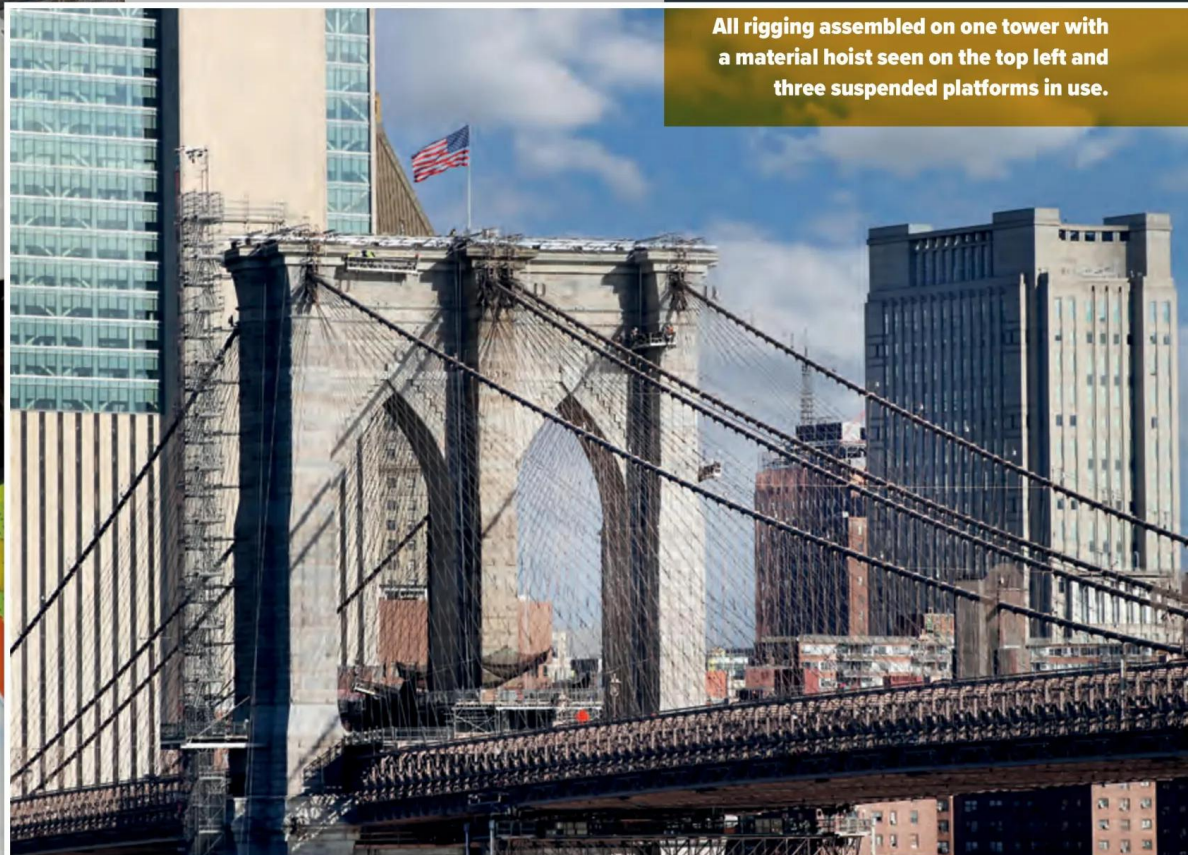
Center photo: Closeup of one monorail running the length of the arch.

Rigging Consultants worked directly with PCS Engineering to determine the location of each attachment point and verify the structural integrity of the system. With the approved attachment points and the dimensions taken during the site visit, Bee Access completed all the fabrication drawings for a total of 22 platforms, two support beams, four monorail beams and 27 rigging beams PER TOWER (see center photo).

Monorails were designed to run parallel with the towers. Between each monorail was a straight platform attached to trolleys located on each monorail. This allowed access to the inside of the arches from the roadway to the apex of the arch (see top photo, page 14.).

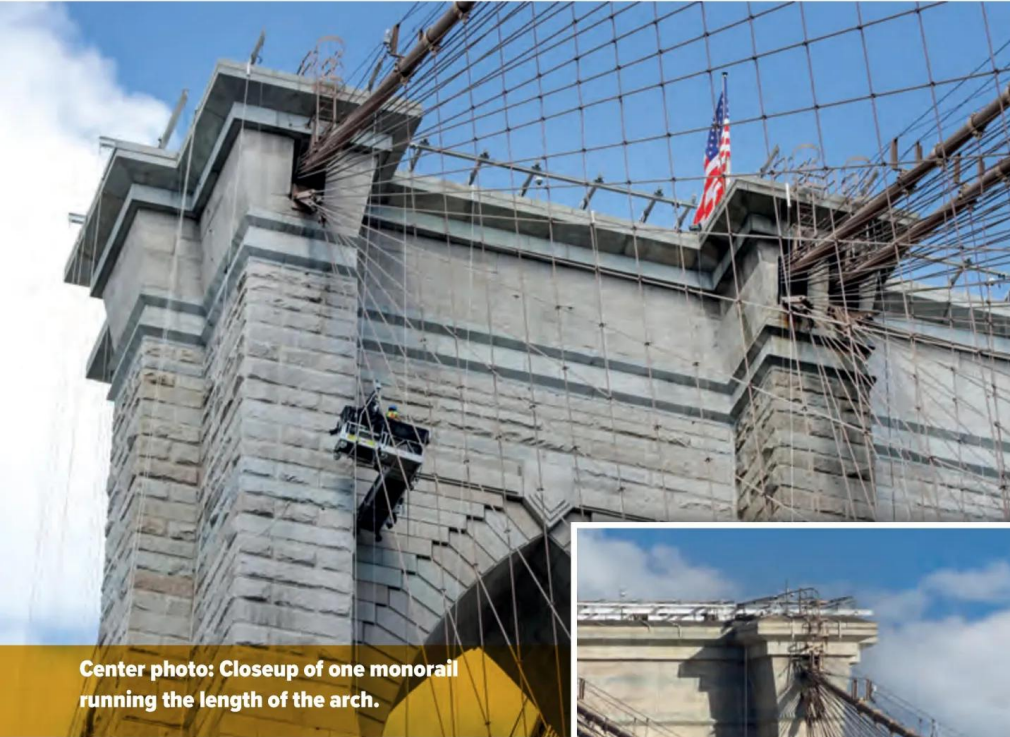
Workers used two suspended platforms to inspect the tower.
